Cowan Ranch Heritage Area Farm Site Historic Structures Report

Washington State Parks

Prepared by The Johnson Partnership, 2007

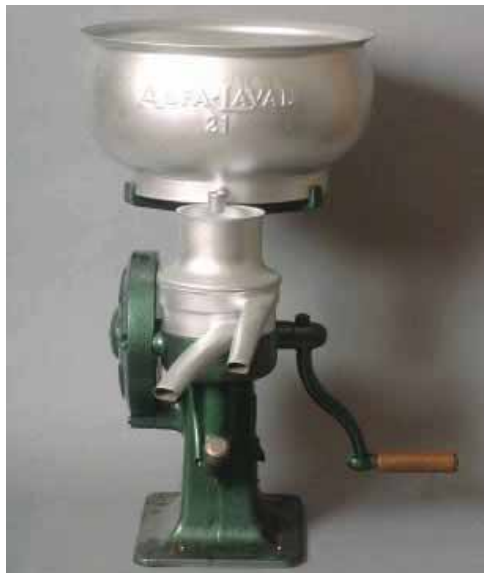
Laval cream separator

In 1879, Swedish inventor, Gustaf de Laval, developed the continuous centrifugal milk separator.¹¹⁶ Prior to the introduction of the separator, milk had been allowed to sit in containers while the cream rose to the top; the cream was then

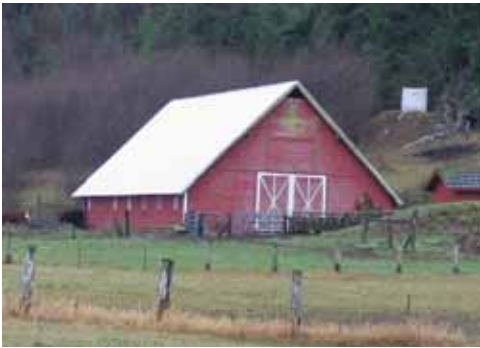
Gable Roof

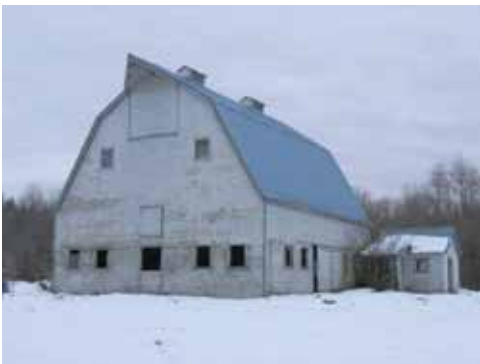
Gambrel Roof

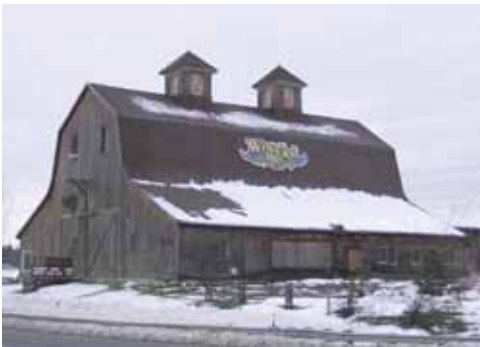
Composite Gambrel Roof

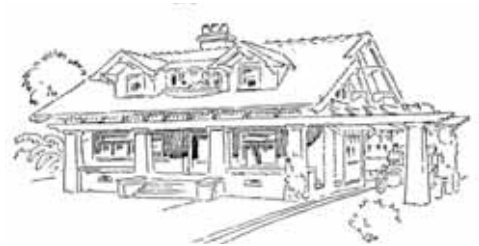
Typical pattern book Craftsman bungalow.

As a “type” we tend to think of bungalows as small rectangular shingled houses, having front porches and simple arrangements of low-sloped gable or hipped roofs with overhangs, the former supported on brackets, the latter often with corbels. Other exterior characteristics include casement or double-hung window

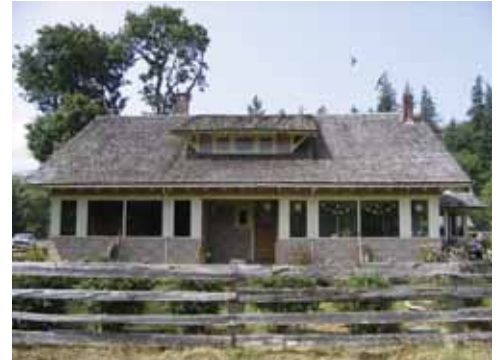
southern elevation

The southern elevation has a doorway to the enclosed main floor level rear porch on its western side. The doorway has a paneled door with an aluminum storm door and is accessed by way of a simple concrete stair with three treads. A simple red painted pipe handrail is mounted on the stairs' northern side, and extends from the door casing to the concrete walk at the base of the stairs. To the east of the doorway is a projecting shed-roofed bay with a pair of one-over-one wood-sash double-hung windows providing light to the bedroom located in the building's southwestern corner. The bay is located approximately 10 feet from the southwestern corner of the building and measures approximately seven feet-six inches wide and projects out approximately 30 inches from the building face. The roof of the bay lacks a gutter. A tripartite group of one-over-one wood-sash double-hung windows provides light into the building's living room. This window group is located approximately 24 feet from the building's southwestern corner. A large non-operable wood-sash plate-glass window is located to the west of the square porch column located at the building's southeastern corner. The second floor has a pair of one-over-one wood-sash double-hung windows centered under the ridgeline. All wood-sash double-hung windows, as well as the porch doorway, on this façade have flat 1x5 casing with an outer back-band. A simple 1x6 stringcourse runs above the main-floor windows abutting the window head casing. The asbestos siding is lapped over the stringcourse. There is also a continuous wood water table located approximately at the floor line. A series of spaced wood brackets, one at the ridgeline and three on each side, supports the gable overhang bargeboard. The two shed dormers also have a single bracket supporting the outer end of their bargeboard.

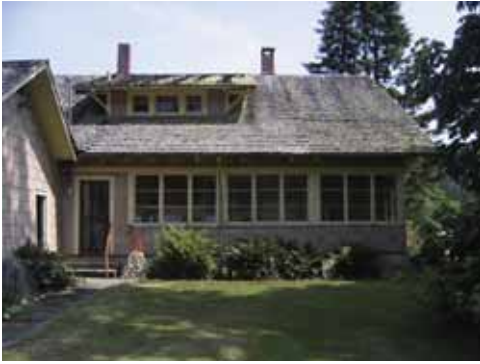
The western elevation of the building is partially obscured by the woodshed that abuts the farmhouse on its northwestern corner. There is an additional doorway to the enclosed rear porch at the northern end of the façade near where the façade abuts the woodshed. The doorway has a paneled door with an aluminum storm door and the doorway is accessed by way of a simple two tread concrete stair with a simple red painted pipe handrail mounted on the stairs' southern side and extending from the door casing to the concrete walk at the base of the stairs. The doorway is cased with a flat 1x5 casing with an outer back-band. The electrical service mast is mounted immediately north of the doorway with the mast extending through the roof. To the south of the doorway and extending to the southwestern corner of the building along the face of the enclosed porch are three groups of windows, each with three, three-light, wood-sash windows, the outer two of which are operable casements. A downspout extends from the roof gutter down to the column between the northernmost window group and the center window group. The roof of this façade also has a shed-roof dormer identical to the one on the eastern side.

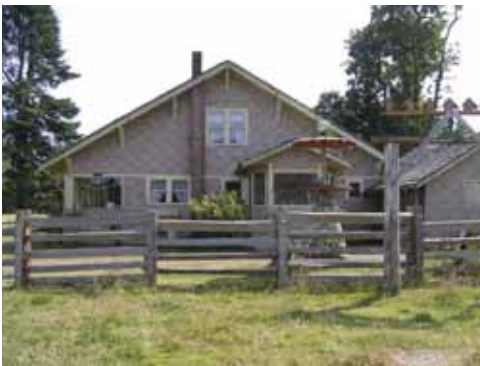
The northern elevation has a large non-operable wood-sash plate-glass window located to the west of the square porch column located at the building's northeastern corner. Two rectangular screened foundation vents are located below floor level beneath the porch window. To the west of the porch window and approximately eleven feet six inches from the northeastern corner of the building is a pair of one-over-one double-hung wood-sash windows providing light to the original dining room. Below and centered on the pair is an exterior mounted wood box with a hinged slanted roof. Immediately to the west of the window pair is a 16-inch square brick masonry chimney extending from grade through the roof overhang. The chimney runs on top of the asbestos siding. To the west of the chimney at grade level is the crawl-space access opening. Also to the west of the chimney is a single one-over-one double-hung wood-sash window that provides light into the current kitchen. Adjacent to and immediately west of this single window is a projecting bay with a simple gable roof with aluminum gutters. The bay is located approximately 24 feet, eight inches from the building's northeastern corner. The bay projects outward approximately 12 feet and is approximately 10 feet, six inches wide where it joins the main wall of the building. The eastern and western walls cant inward approximately two feet beginning at a point approximately eight feet outward from the wall of the main building, ending with a northern wall that is approximately eight feet six inches wide. The bay is glazed with simple non-operable aluminum-sash windows with wood intermediate vertical mullions on the eastern side and on the canted bays, with a simple non-operable wood-sash window on the northern side, and with one operable sliding aluminum window at the north end of its western side, and a non-operable aluminum-sash window with obscure glazing on its southern end. The bay foundation is exposed, has rectangular plastic foundation vents, and extends upward to the plate of the floor joists. The eastern and western lower walls of the bay are covered with hand-split wood shakes, while the two canted walls and the northernmost wall are covered with asbestos siding. The northern bay corners have vertical corner boards. A small one-over-one double-hung wood-sash window is located two-feet, eight-inches from the building's western corner. Another pair of one-over-one double-hung wood-sash windows is located on the second floor, centered under the ridgeline. With the exception of the projecting bay, the northern façade is similar to the southern façade, with the same window casing, stringcourse, and water table.

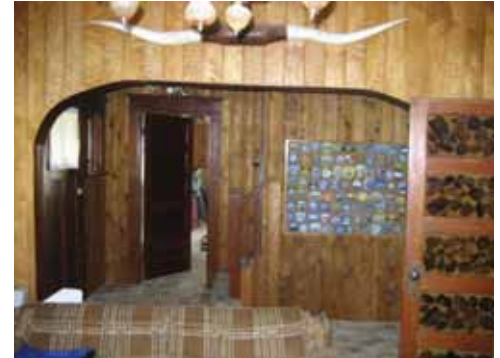
Farmhouse interior viewing south to entry

The enclosed porch measures approximately 17 feet, six inches north-to-south and seven feet, six inches east-to-west and has asbestos siding on its western wall, while the northern and eastern walls are primarily glazed. The ceiling is painted "beaded-ceiling" running north-to-south. The southern porch wall has a pair of French doors within a primarily glazed wall panel.

The living room is located on the southern side of the entry and is accessed by way of a 30-inch doorway located between the eastern building wall and the stairway. The room measures approximately 20 feet north-to-south, by approximately 14 feet east-to-west. This room is paneled with what appears to be a mixture of pine, cedar, and "bird's eye" maple V-groove vertical 1x6 boards, extending from the floor to a painted picture rail placed at the level of the crown of the door lintels. Above the picture rail the upper wall is painted paper or fabric, as is the ceiling. A large projecting woodstove surround is centered on the western wall of this room. This surround is surfaced with sliced stalactites and is approximately six feet wide, projects approximately three feet into the room from the western wall, and is approximately seven feet, four inches high. The cast iron stove is placed with a central recess with a brick half-round arch. A brass Life Guard Service emblem is glued to the arch keystone.²¹³ The chimney flue for what would appear to be the original fireplace extends from the top of the surround to the room's ceiling. The stove surround is flanked by a pair of doors located near the corner of the room, the southern door leading to the southwestern bedroom and the northern door leading to a central hallway. The southern wall has a large tripartite window. The eastern wall has a three-

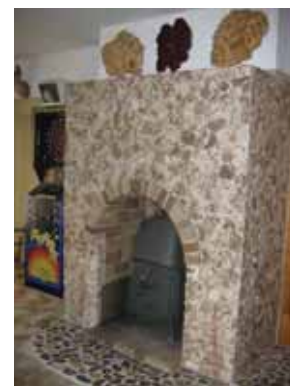
Living room stove

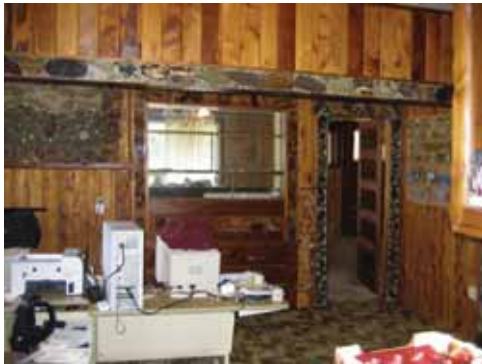
Farmhouse kitchen viewing southwest

section aluminum sliding glass door leading to the southern enclosed porch. The casing around the sliding doors appears to be a modified window casing, with a narrower jamb casing and an inserted head section. Numerous mounted animal heads and wood burls are mounted around the room on the upper painted wall section above the picture rail or on the door head trim.

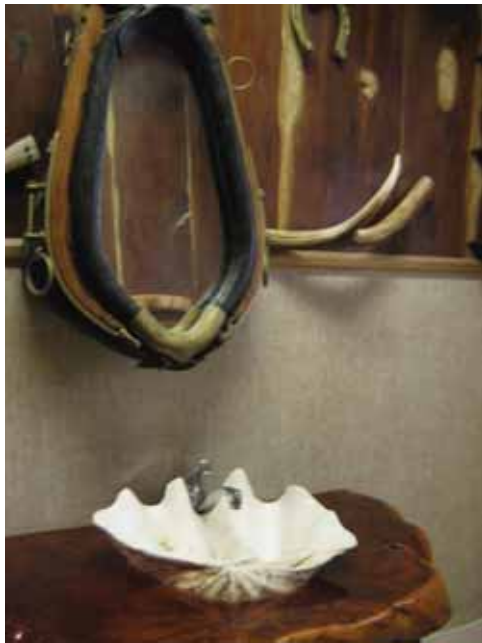
Farmhouse bathroom sink

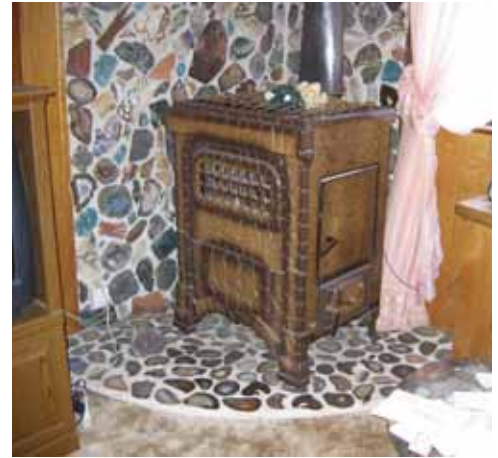
Dining room stove

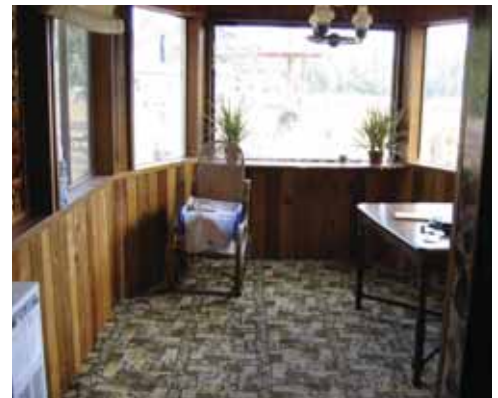
Kitchen nook viewing north

The dining nook is a large projecting bay measuring approximately nine feet, six inches wide east-to-west, and approximately 12 feet deep north-to-south. The bay is glazed on three sides, viewing out directly too the north at a large birdfeeder. The lower walls have a mixed wood wainscot of V-groove vertical 1x6 boards. The southernmost window on the western side of the nook has a translucent lapidary panel. A “western-style” chandelier hangs from the center of the ceiling. The opening to the dining nook is also finished with lapidary panels extending from the floor to the ceiling and across the lintel. The alcove on the eastern side of the kitchen area is defined by a beam/header spanning north-to-south. The alcove measures approximately 14 feet wide in the north-to-south direction and is approximately five foot deep in the east-to-west direction. The separating header is cased with lapidary panels on the sides and bottom and the upper portion is paneled with mixed specie V-groove vertical 1x6 boards. The eastern wall of the alcove has the rear side of the dining room display case with open upper shelves and lower drawers. The drawers are faced with Lawson cedar and have horn handles. The upper portion of the cabinet is cased with lapidary panels, as is the adjacent door to the south. The alcove contains additional mounted mosaic and lapidary pieces.

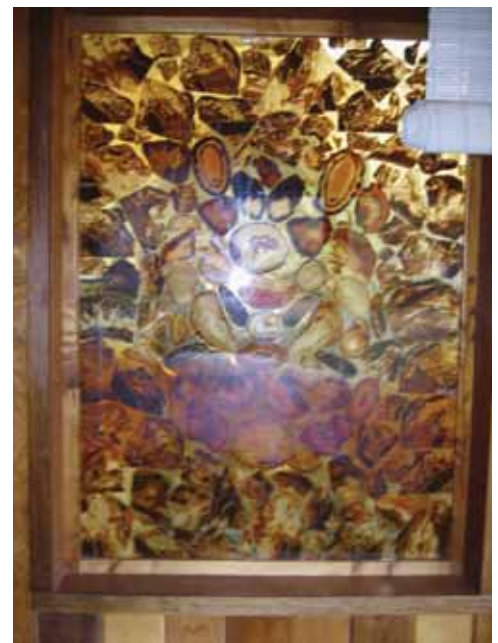
Lapidary window

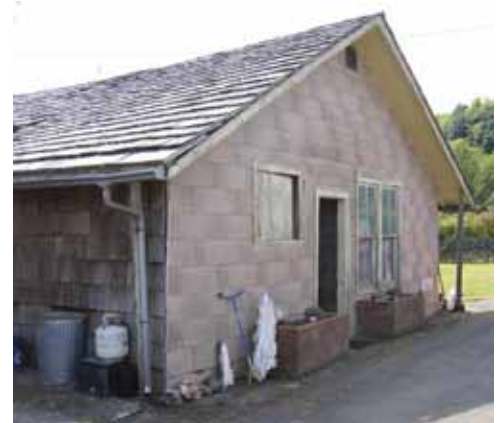
north elevation

The Woodshed's southern elevation has a three-panel door on its eastern side and a pair of tall four-light casement windows located approximately five feet from the building's southwestern corner. The western elevation of the building is blank and is currently used to display a collection of net floats. The northern elevation has a square shuttered window located five feet from the building's northeastern corner. A three-panel door is located approximately nine feet from the building's northeastern corner. A pair of tall four-light casement windows is located approximately five feet from the building's northwestern corner. A nearly square window opening with a hinged wooden shutter is located to the east of the doorway. Two rectangular brick masonry planters, each measuring approximately 24 inches deep, by 48 inches long, by 21 inches high, flank the doorway. The eastern elevation is partial, due to its intersection with the farmhouse and it is blank and covered with hand-split shakes.

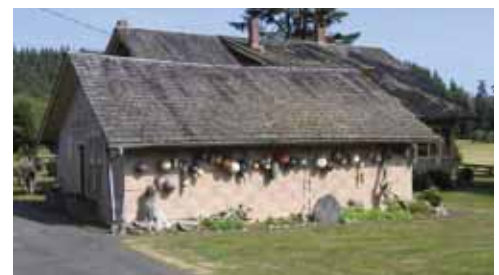
east elevation
